Determination of the Raise Categories for Sparsely-Documented Tailings Dams in British Columbia, Canada

Steven H. Emerman, Ph.D., Malach Consulting, LLC, 785 N 200 W, Spanish Fork, Utah 84660, USA, Tel: 1-801-921-1228, E-mail: SHEmerman@gmail.com

Report prepared for BC Mining Law Reform and SkeenaWild Conservation Trust
Submitted February 8, 2022, revised February 21 and June 13, 2022

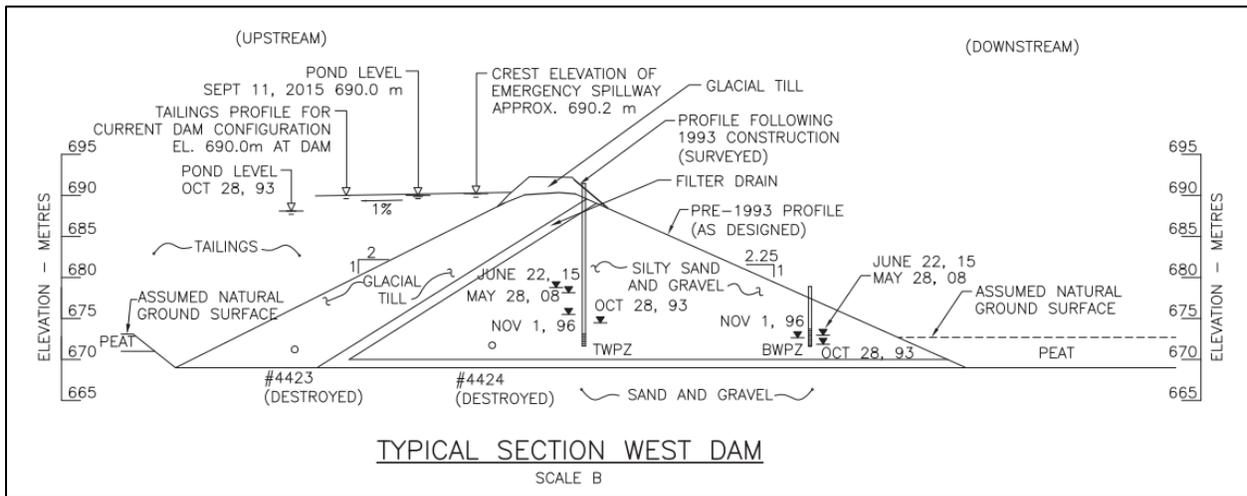
Figure 8a. The West Dam at the Goldstream (Revelstoke) mine site is 23 meters high and constructed from compacted earthfill. According to Klohn Crippen Berger (2016), planned dam raises were never completed. The above cross-section confirms that the West Dam is a single-stage dam. Portion of figure from Klohn Crippen Berger (2016).

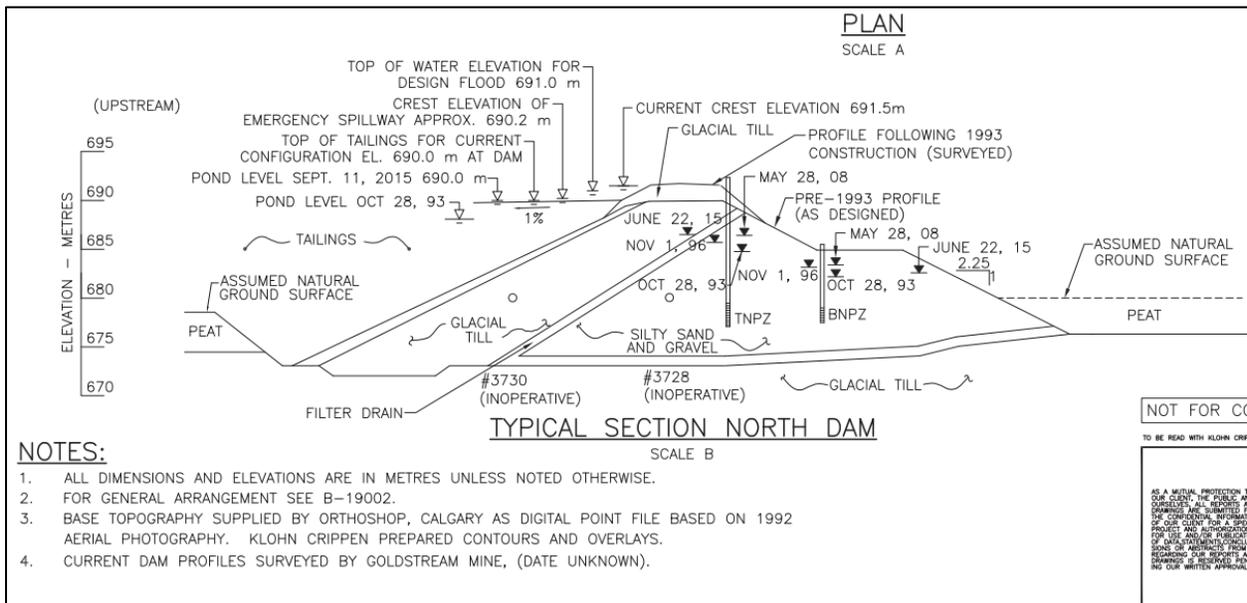
Figure 8b. The North Dam at the Goldstream (Revelstoke) mine site is 16 meters high and constructed from compacted earthfill. According to Klohn Crippen Berger (2016), planned dam raises were never completed. The above cross-section confirms that the North Dam is a single-stage dam. Portion of figure from Klohn Crippen Berger (2016).

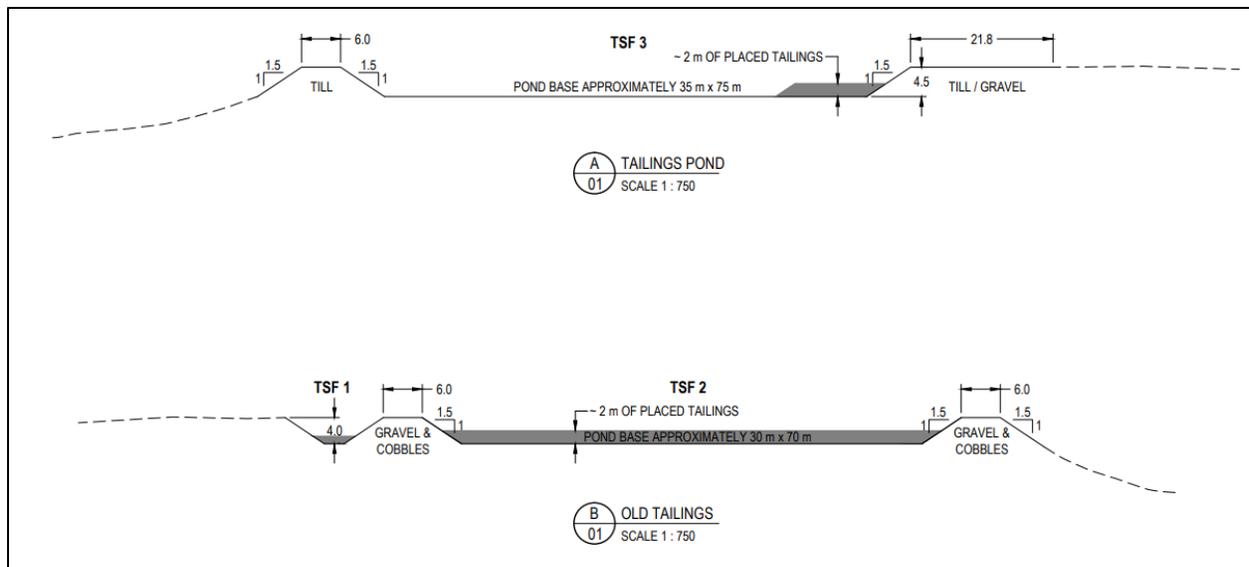
Figure 9. Based on the above cross-sections, the Yellowjacket mine site seems to include only single-stage dams. Portion of figure from Tetra Tech Canada (2014).

Out of the 19 mine sites (see Table 1), four include cross-sections that can be compared with the standard cross-sections of upstream, downstream and centerline dams (see Figs. 2a-c), including one overlap with the six mine sites discussed in the previous subsection. The Goldstream (Revelstoke) mine site was explicitly described as a single-stage dam by Klohn Crippen Berger (2016) who also presented cross-sections (see Figs. 8a-b). The cross-sections of the West Dam and North Dam show single-stage dams with no evidences of dam raises, aside from raising the dam crests by 1.5 meters in 1993 with a cap of glacial till (Klohn Crippen Berger, 2016; see Figs. 8a-b). The cross-sections of the tailings dams at the Yellowjacket mine site also show single-stage dams with no evidence of dam raises (Tetra Tech Canada, 2014; see Fig. 9). The single-stage status of the tailings dams at the Yellowjacket site is further reinforced by the low heights (4 meters for TSF1 and TSF2, 4.5 meters for TSF3) of the dams (see Table 1 and Fig. 9).

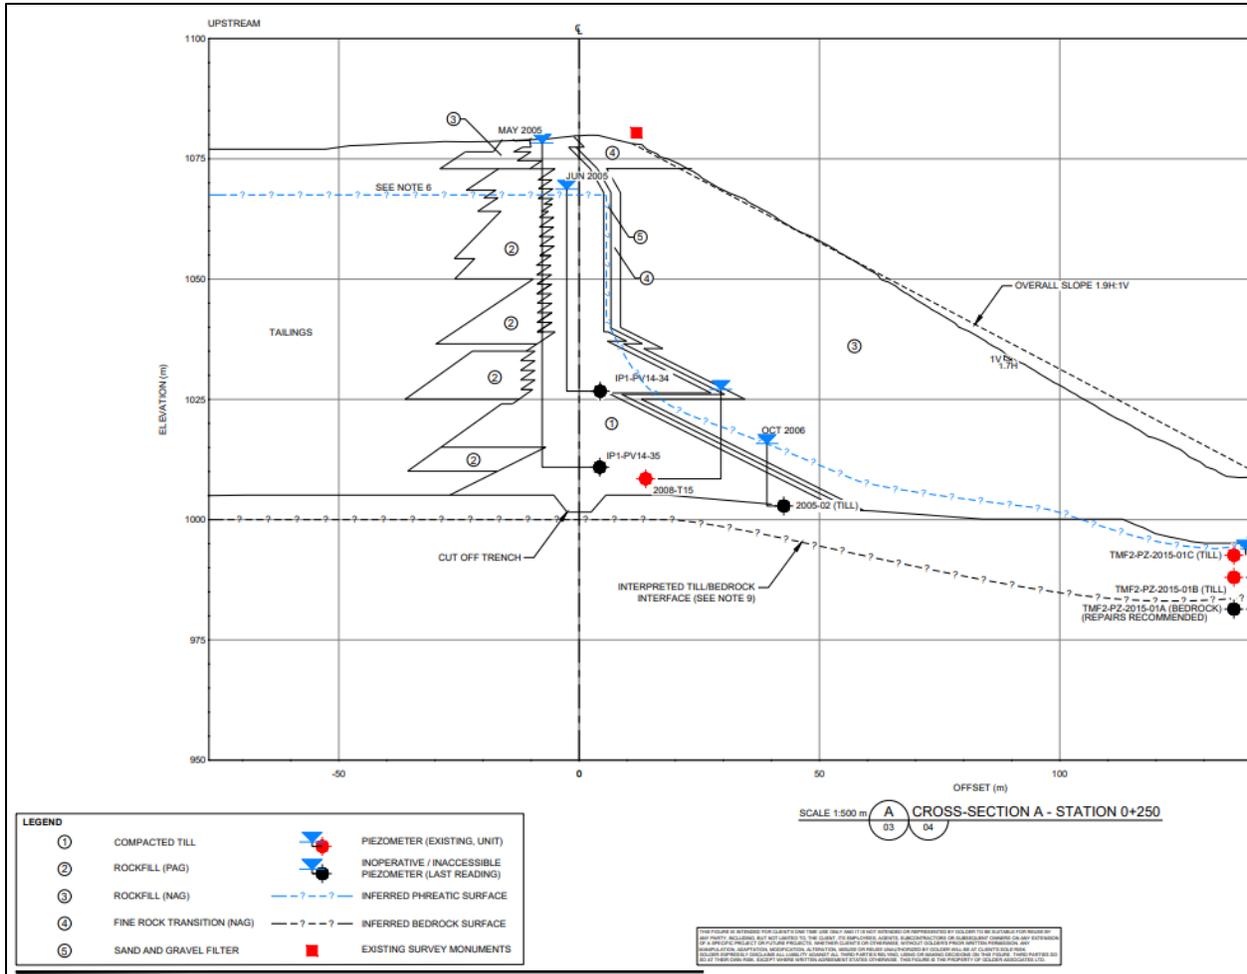
The Huckleberry mine site includes five tailings dams, two of which (TMF-2 Main Dam and East Pit Plug Dam) were clearly constructed using the centerline method based upon the cross-sections (Golder Associates, 2021; compare Figs. 10a-b with Fig. 2c). The successive raises were constructed by placing potentially acid-generating (PAG) rockfill on the tailings beach and non acid-generating (NAG) rockfill on the slope downstream of the previous dike with a final cap of NAG rockfill on the upstream side of the dam (see Figs. 10a-b). According to Golder Associates (2021), “The core [of the East Pit Plug Dam] is supported upstream by a waste rock shell.” As required in the centerline method, the central lines of the raises coincided as the dam was built upwards (compare Figs. 10a-b with Fig. 2c). The TMF-3 Main Dam and TMF-3 Saddle Dam are currently single-stage dams (based on the black lines in Figs. 10c-d) with the intention to raise to an “ultimate design crest” (based on the gray lines in Figs. 10c-d) using the centerline method (compare with Fig. 2c). The TMF-3 Main Dam and TMF-3 Saddle Dam will be raised by placing PAG waste rock on the tailings beach and NAG waste rock on the slope downstream of the previous dike with a final cap of NAG rockfill on the upstream side of

Figure 10a. The TMF-2 Main Dam at the Huckleberry mine site is 90 meters high and was constructed out of rockfill and glacial till. Based on the above cross-section, the dam was clearly raised using the centerline method (compare with Fig. 2c). Portion of figure from Golder Associates Ltd. (2021).

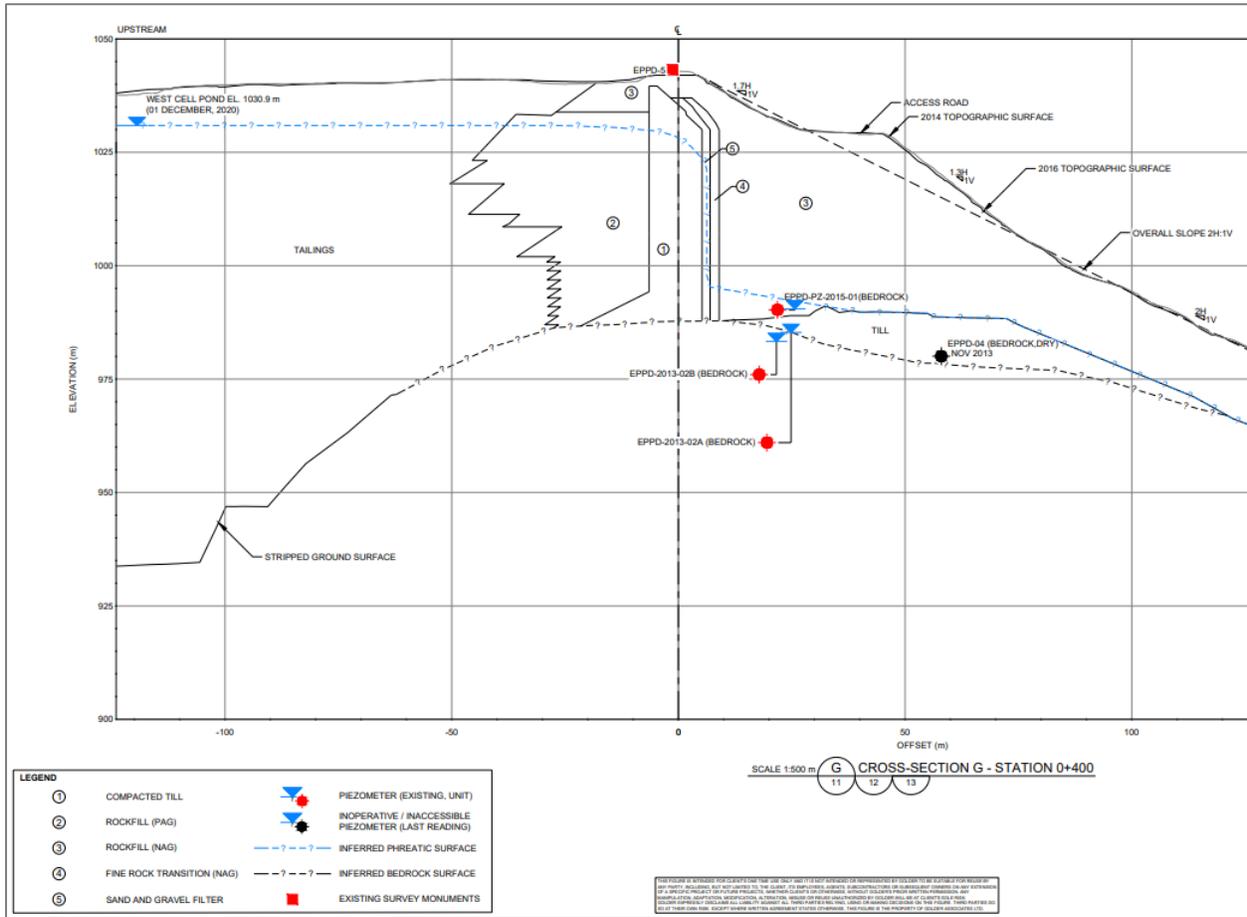
Figure 10b. The East Pit Plug Dam at the Huckleberry mine site was constructed out of natural rockfill, natural earthfill, and mine waste rock. Based on the above cross-section, the dam was clearly raised using the centerline method (compare with Fig. 2c). Portion of figure from Golder Associates Ltd. (2021).

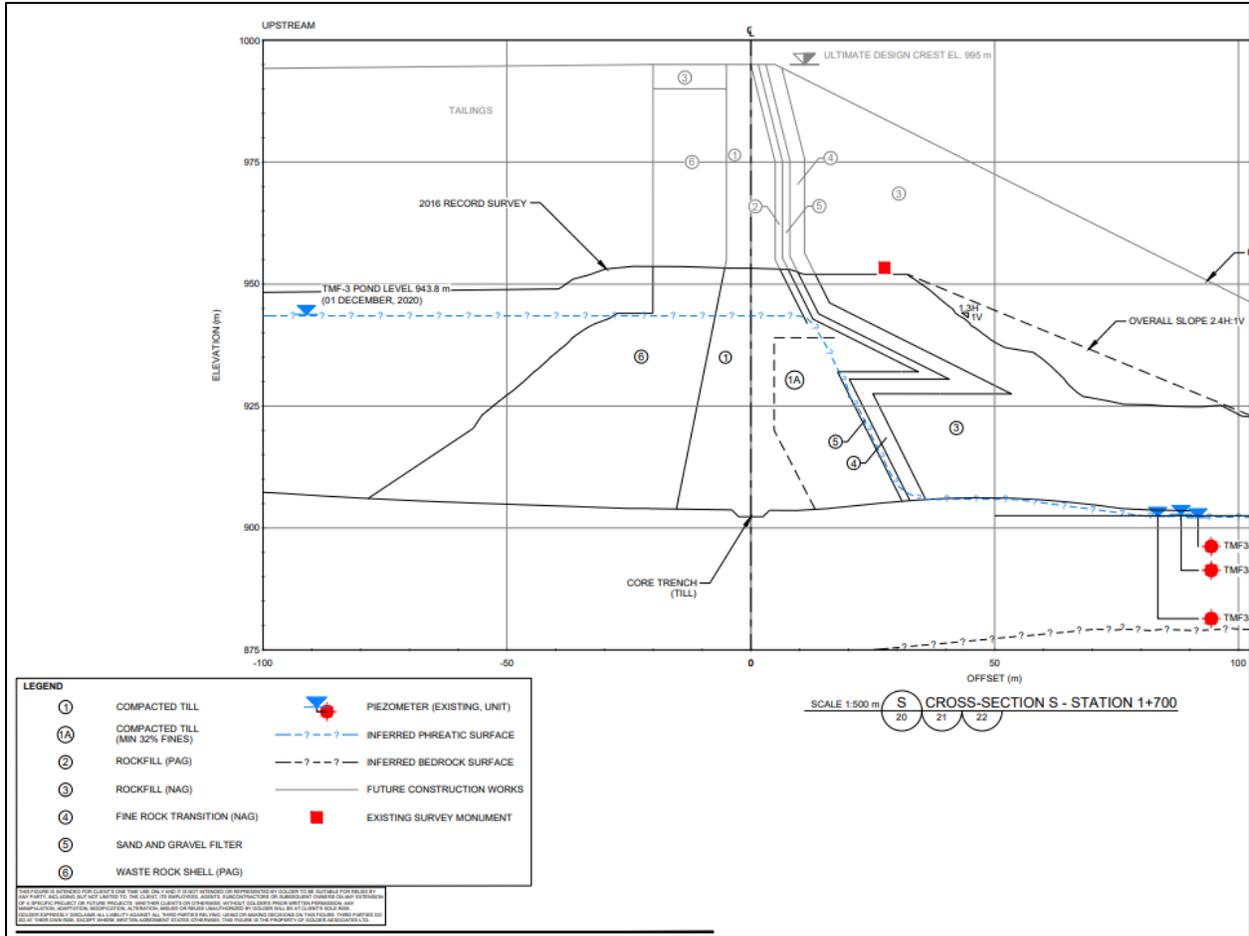
the dam (see Figs. 10c-d). The current diagrams show the raises in a generalized manner with vertical slopes for the anticipated raises (see Figs. 10c-d). It should be understood that raises cannot actually be constructed with vertical slopes and that the construction material will be placed on top of the tailings beach (see Figs. 10a-b). Based on its cross-section (see Fig. 10e), the TMF-2 Orica Saddle Dam at the Huckleberry mine site is a single-stage dam with no raises (compare with Figs. 2a-c). The height of 10 meters is further evidence that the TMF-2 Orica Saddle Dam is a single-stage dam. As discussed in the Methodology, the discussion of the Huckleberry mine site by Golder Associates (2021) does not make a clear distinction between mine waste rock and other sources of rockfill.

Figure 10c. The TMF-3 Saddle Dam at the Huckleberry mine site was constructed out of natural rockfill, natural earthfill, and mine waste rock. The dam is currently a single-stage dam (based on the black lines) with the intention to raise to an “ultimate design crest” (based on the gray lines) using the centerline method (compare with Fig. 2c). Portion of figure from Golder Associates Ltd. (2021).

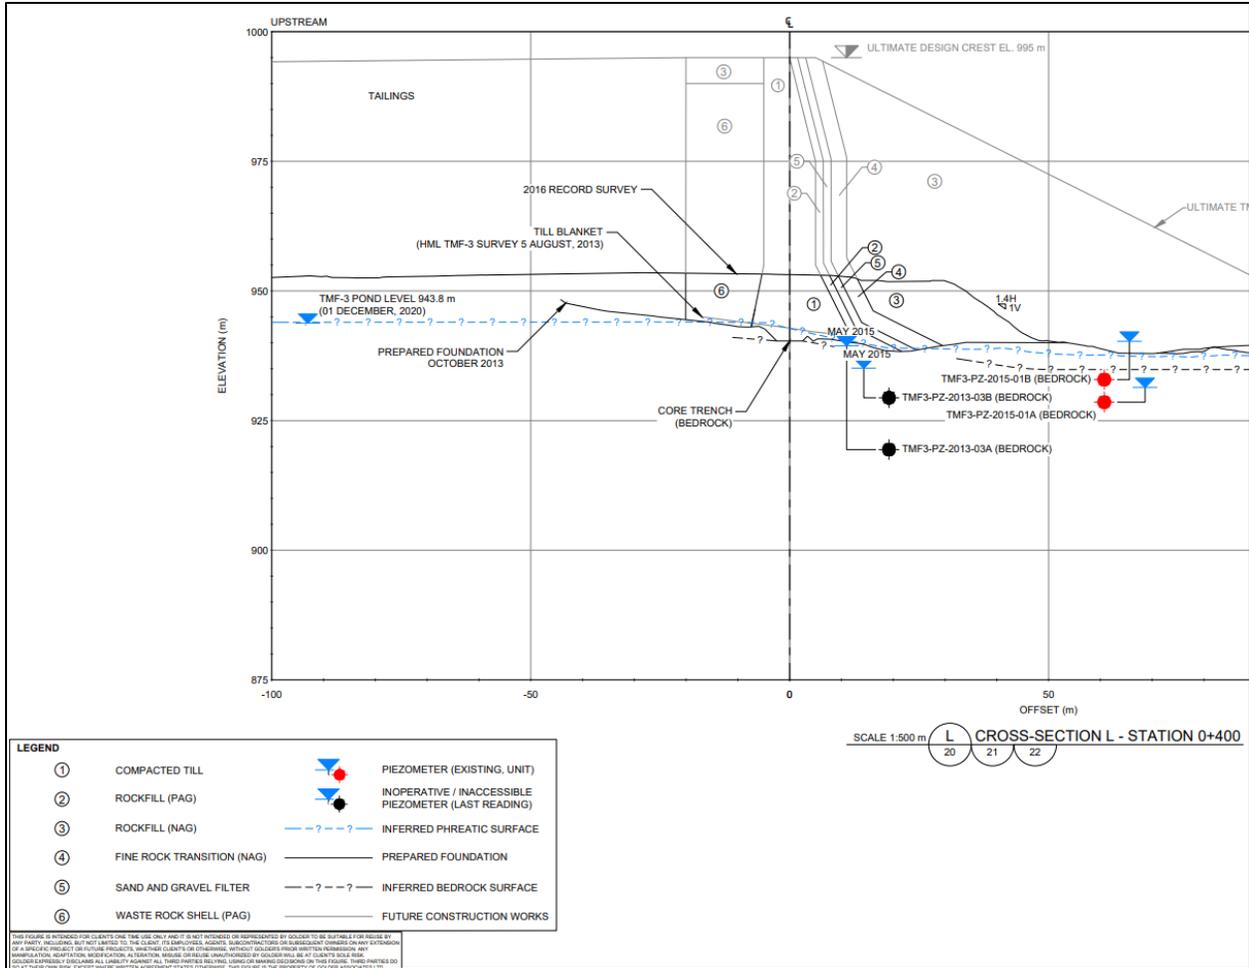
Figure 10d. The TMF-3 Saddle Dam at the Huckleberry mine site was constructed out of natural rockfill, natural earthfill, and mine waste rock. The dam is currently a single-stage dam (based on the black lines) with the intention to raise to an “ultimate design crest” (based on the gray lines) using the centerline method (compare with Fig. 2c). Portion of figure from Golder Associates Ltd. (2021).

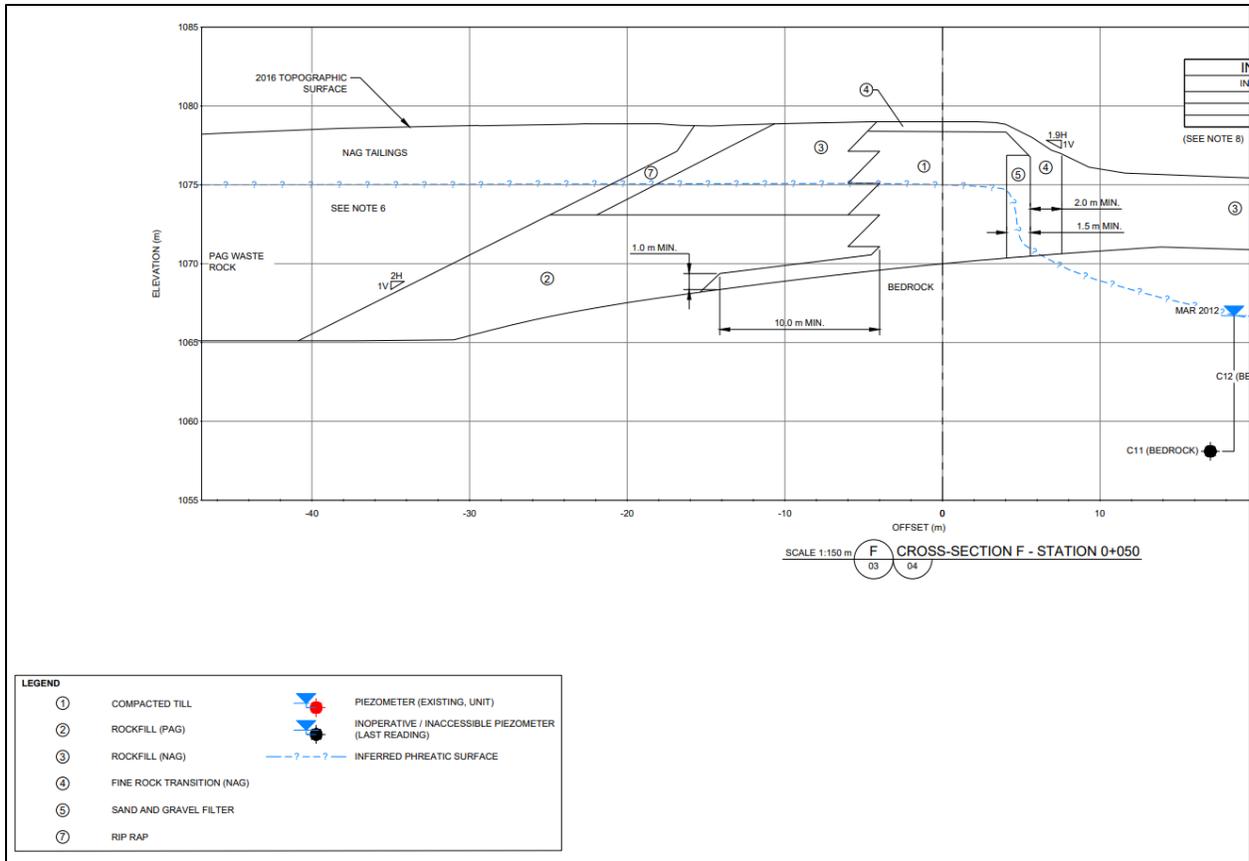
Figure 10e. The TMF-2 Orca Saddle Dam at the Huckleberry mine site is 10 meters high and was constructed out of rockfill and glacial till. Based on the above cross-section, the dam is clearly a single-stage dam with no raises (compare with Figs. 2a-c). The short height (10 meters) is further evidence that the TMF-2 Orca Saddle Dam is a single-stage dam (see Fig. 7). Portion of figure from Golder Associates Ltd. (2021).

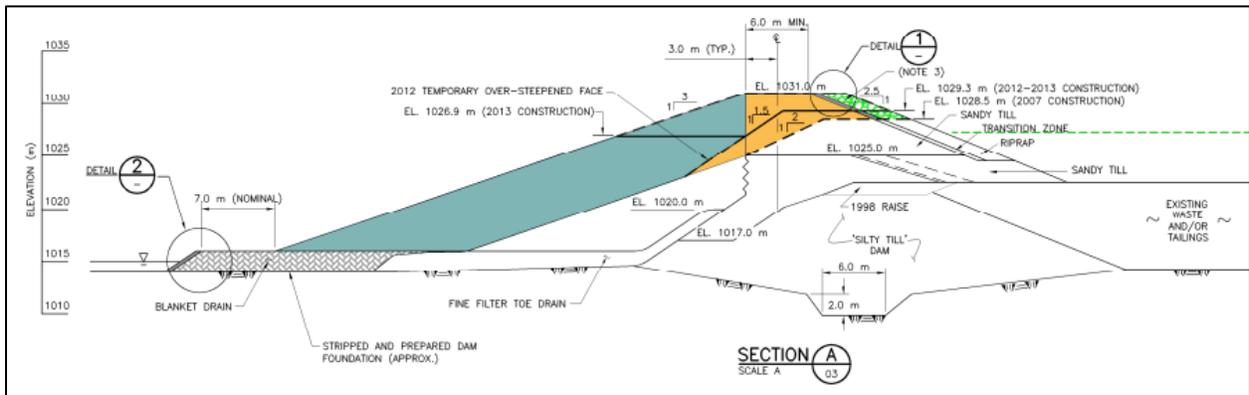
Figure 11a. The above cross-section shows progressive dam raises in the downstream direction (compare with Fig. 2b), indicating that the Cross Dyke at QR Mine TSF is a downstream dam. Note that the downstream dam retains some of the vulnerability to failure of an upstream dam since an upstream embankment of “sandy till” was placed on top of “existing waste and/or tailings” Portion of figure from Klohn Crippen Berger (2021a).

A cautionary note is that, at one of the mine sites (QR Mine TSF; see Table 1 and Figs. 11a-c), part of the foundation for the new tailings dams was existing tailings or waste rock. There are probably other examples of tailings dams in British Columbia that have been constructed on top of tailings. Although it was not one of the mine sites investigated in this report, cross-sections of the tailings dams at the Table Mountain site appear in the same Dam Safety Inspection report as the Taurus Gold site (Tetra Tech, 2017). One of the Table Mountain cross-sections shows a single-stage dam apparently constructed on top of an existing single-stage dam and its impounded tailings (see Fig. 13). The zone numbering in Fig. 13 is not defined in Tetra Tech Canada (2017). The zone numbers are not being used in a standard way, since a more standard numbering is Zone 1 (earthfill core), Zone 2A (fine filter drain), Zone 2B (coarse filter drain), and Zone 2C (upstream filter) (Fell et al., 2015).

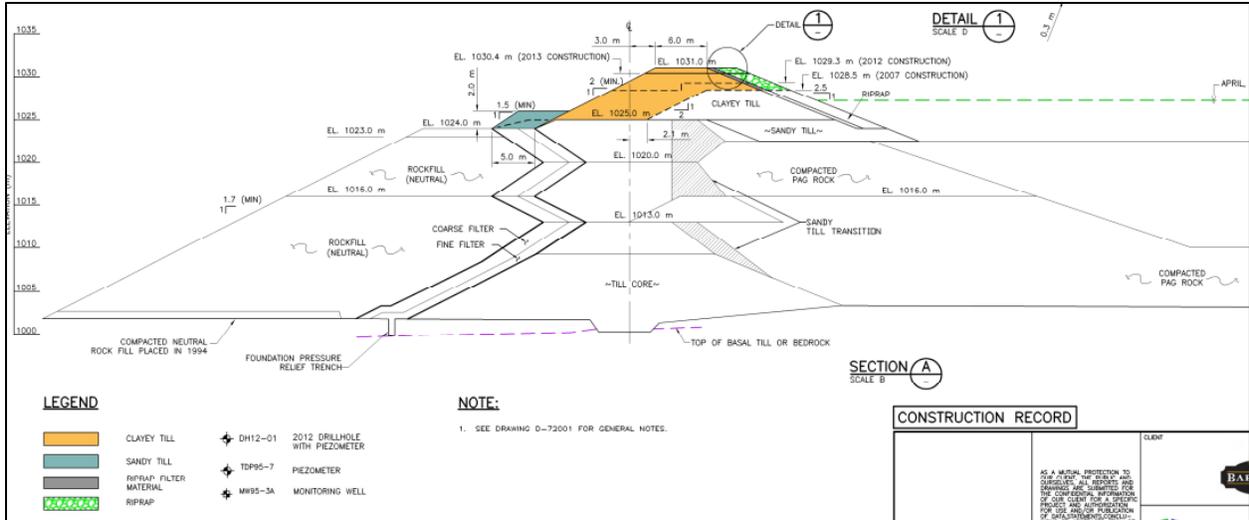
The two tailings dams at the QR Mine TSF site (called Cross Dyke and Tailings Dam) are clearly downstream dams based on the cross-sections (Klohn Crippen Berger, 2021a; compare Figs. 11a-b with Fig. 2b). Note that Cross Dyke retains some of the vulnerability to failure of an upstream dam since an upstream embankment of “sandy till” was placed on top of “existing waste and/or tailings” (Klohn Crippen Berger, 2021a; see Fig. 11a). The cross-section for Tailings Dam at QR Mine TSF has been divided into a downstream (left-hand) portion (see

Figure 11b. The above cross-section shows progressive dam raises in the downstream direction (compare with Fig. 2b), indicating that the Tailings Dam at QR Mine TSF is a downstream dam. See upstream (right-hand-side) of cross-section continued in Fig. 11c). Portion of figure from Klohn Crippen Berger (2021a).

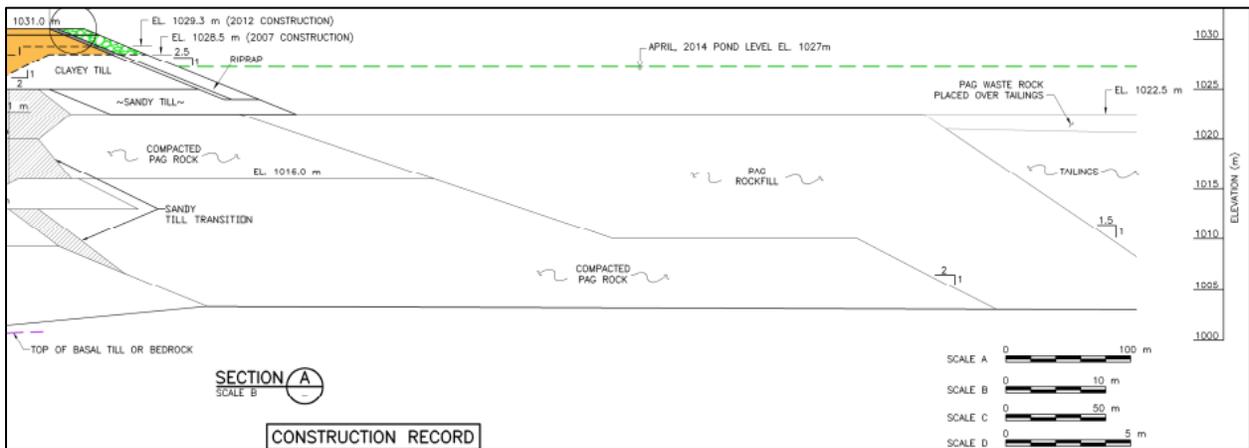
Fig. 11b) and an upstream (right-hand) portion (see Fig. 11c). Tailings Dam also retains some of the vulnerability to failure of an upstream dam since PAG waste rock has been placed on top of tailings (see Fig. 11c).

Figure 11c. The above cross-section shows progressive dam raises in the downstream direction (compare with Fig. 2b), indicating that the Tailings Dam at QR Mine TSF is a downstream dam. Note that the downstream dam retains some of the vulnerability to failure of an upstream dam since PAG (potentially acid generating) waste rock has been placed on top of tailings. See downstream (left-hand side) of cross-section continued in Fig. 11b). Portion of figure from Klohn Crippen Berger (2021a).

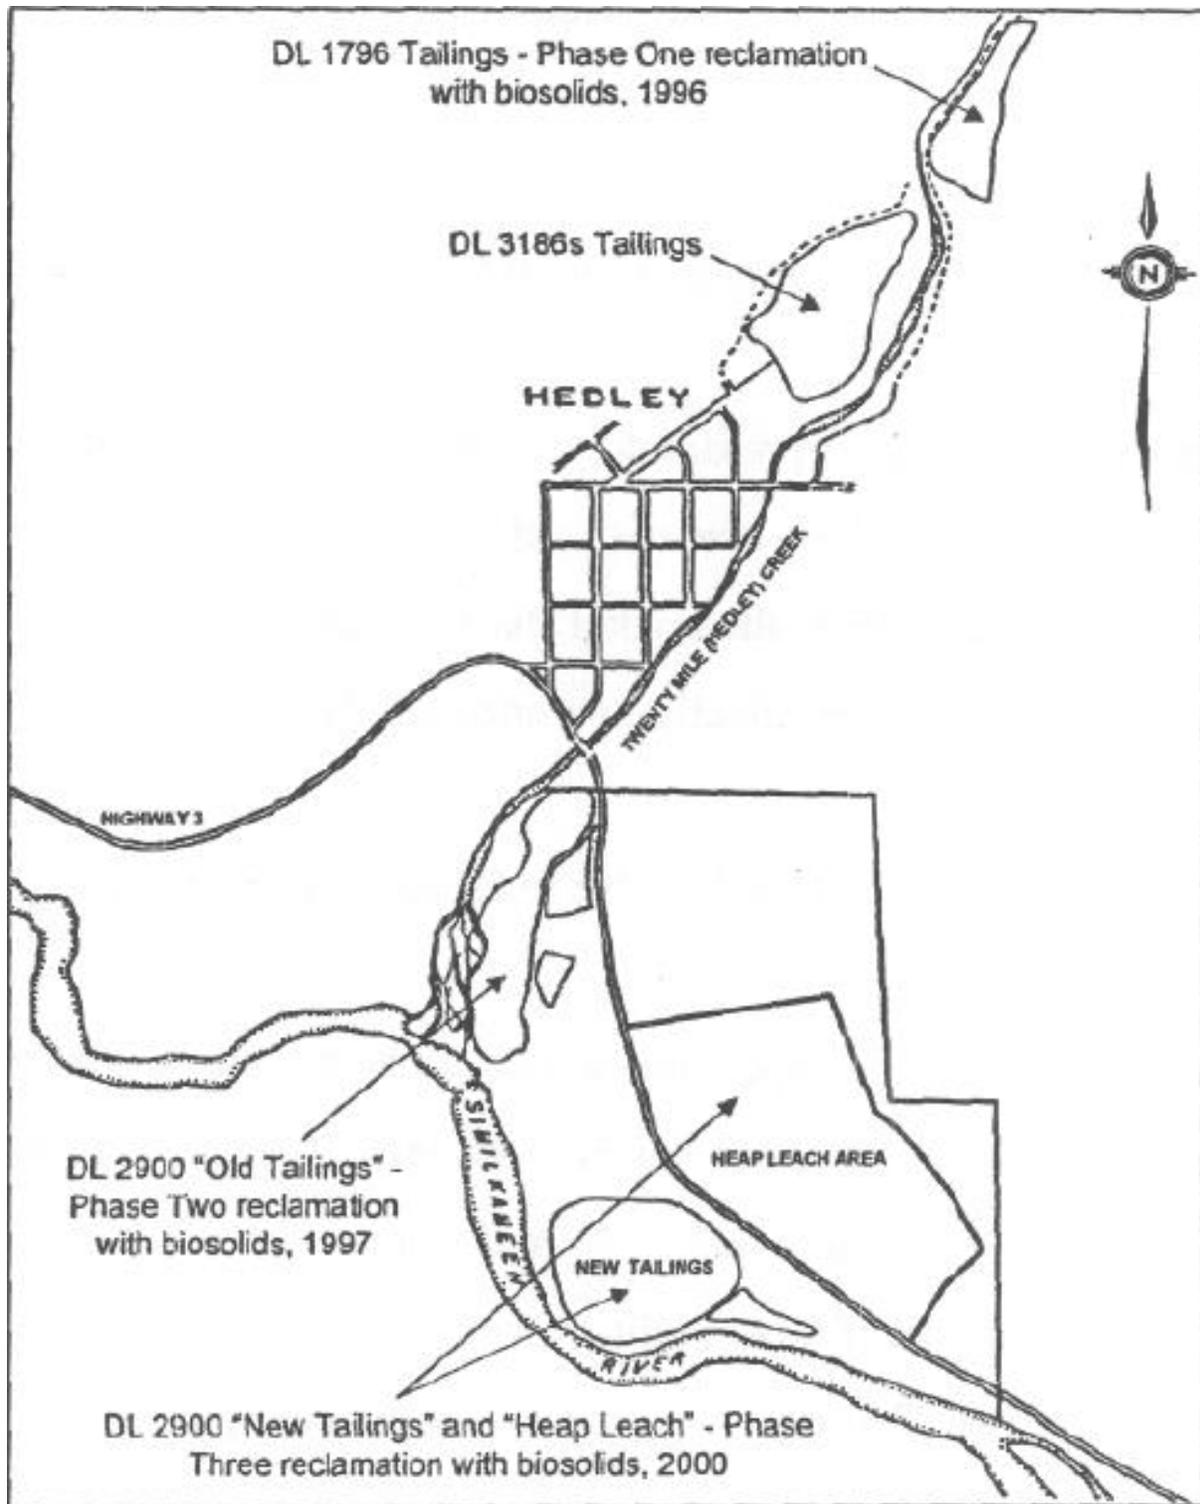
Figure 12. The tailings at the Candorado/Hedley site should be regarded as the least stable since the tailings were simply heaped with no dam or impoundment and no indication of dewatering and compaction. According to Horton and Kempe (2001), "Tailings previously deposited by the historic Mascot and Nickel Plate mining operations were mined, agglomerated with cement, progressively stacked into a seven hectare heap through a series of pads and leached with a cyanide solution to extract gold." The placement of the tailings along the banks of streams should be a matter of particular concern. Figure from Horton and Kempe (2001).

There is one mine site that is classified as Other. At the Candorado/Hedley mine site, there are no engineered tailings facilities, but only free-standing heaps of tailings with no dams or impoundments of any kind (see Table 1 and Fig. 12). There is certainly no indication that the tailings were filtered (dewatered) and compacted, which would create the possibility of some geotechnical stabilization. According to the proposal by Ash (1986), “The tailings consist of 2 large piles ... The tailings will be picked up by earth moving equipment, hauled to the agglomeration area, dumped into a hopper, conveyed to an agglomeration plant, and thence to leach pads where cyanide solutions, will be sprayed, percolated through, and collected for processing in a central processing plant.” According to the most recent description, “Tailings previously deposited by the historic Mascot and Nickel Plate mining operations were mined, agglomerated with cement, progressively stacked into a seven hectare heap through a series of pads and leached with a cyanide solution to extract gold” (Horton and Kempe, 2001). The agglomeration with cement is a means of converting clay-sized tailings into pellets and should not be regarded as a means of stabilizing the tailings heaps. According to Ash (1986), “The tailings particles of the Hedley tailings piles are so finely-ground that they may be entirely classed as being ‘clay-sized,’ and cannot be heap-leached by normal means. However, by the process of agglomeration, blinding does not occur, excellent percolation characteristics may be maintained, and the pellets are porous, thus allowing the cyanide solution to pass directly through, dissolving and picking up all the ‘exposed’ gold. Agglomeration is the forming of semi-spherical pellets by combining tailings with cement and/or lime, and a small amount of water, rolling the mixture around ... These pellets are then stacked by a stacking conveyor onto a large leach pad.”

On the other hand, the greatest concern should not be upstream dams, but tailings that are simply sitting in heaps with no dam or impoundment of any kind, such as at the Candorado/Hedley mine site (see Table 1 and Fig. 12). Although the various heaps at the Candorado/Hedley mine site have now been reclaimed with biosolids (Horton and Kempe, 2001), there have been no measurements or modeling that have demonstrated the geotechnical stability of the heaps. In fact, Horton and Kempe (2001) have claimed only that “Forage establishment with biosolids was successful for all reclaimed tailings areas, improving their aesthetics and dust control.” The placement of the tailings heaps along the banks of streams should be a matter of particular concern (see Fig. 12).

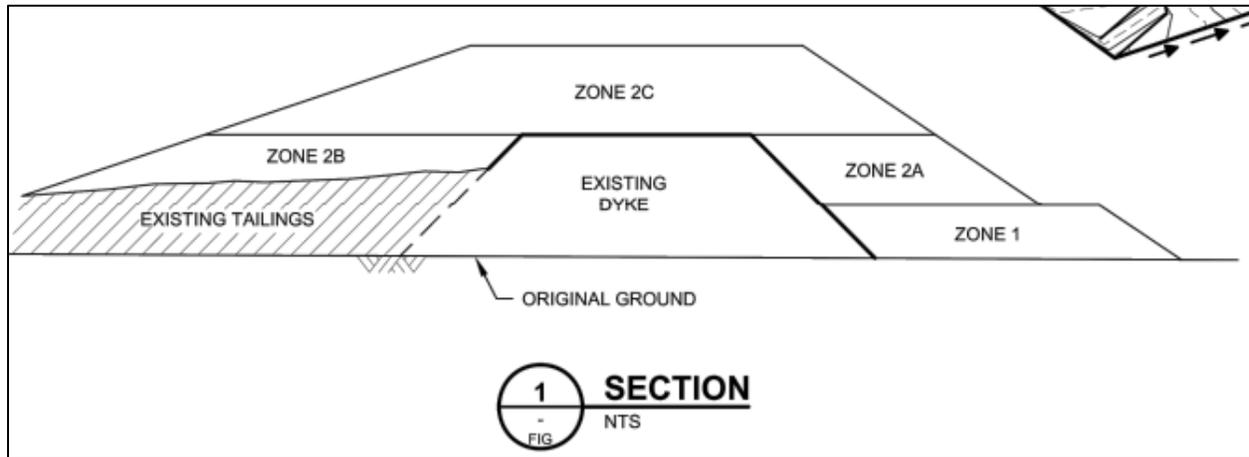
Figure 13. Based on the above cross-section, the Table Mountain site seems to include a single-stage dam constructed on top of and incorporating an existing dam with impounded tailings. The text (Tetra Tech Canada, 2017) does not clarify the meanings of the zones, which do not use standard nomenclature. Note that the presence of Zones 2B and 2C on top of “existing tailings” means that the Taurus Gold tailings dam has some of the vulnerability to failure of an upstream dam (compare with Fig. 2a). Portion of figure from Tetra Tech Canada (2017).
